4. APPENDIX A: INSULCORE™ SOLUTIONS REPAIR EXAMPLES

4.1. 13.7 MW Rotor Core Repair

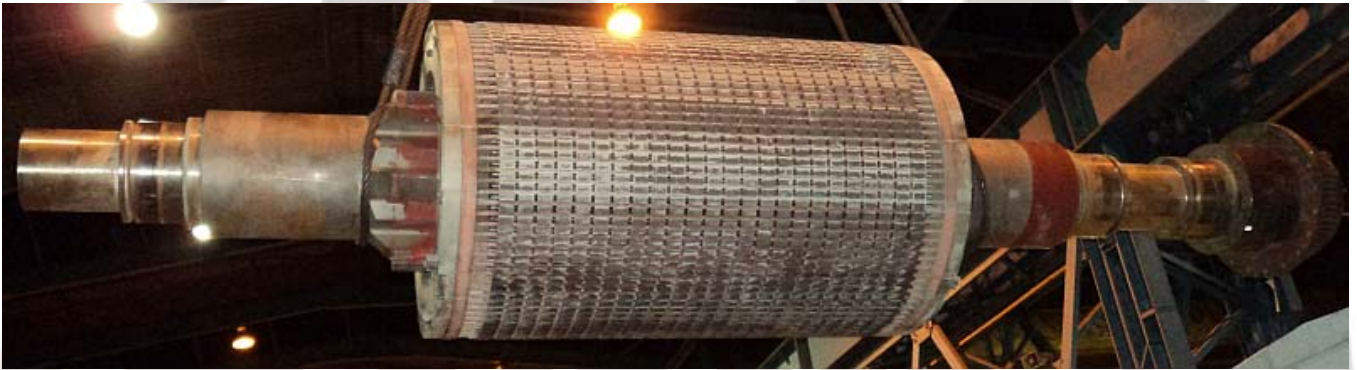
This 4 pole motor had a rotor core inter-laminar deterioration problem resulting in severe vibration problems.

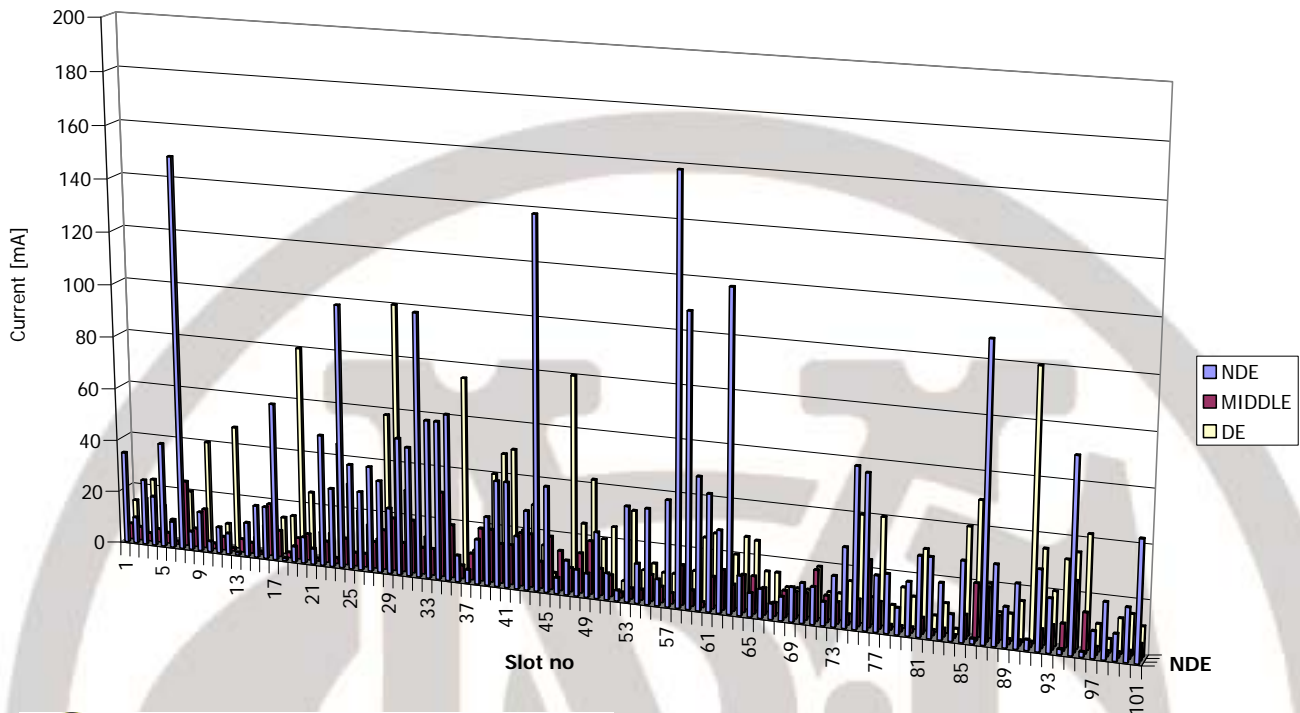
Elcid Test: Original Rotor Core Test Results

10 of the El Cid results were out of specification.

We recommended that the core could be treated using the InsulCore™ Solution treatment as a possible solution to the problem.

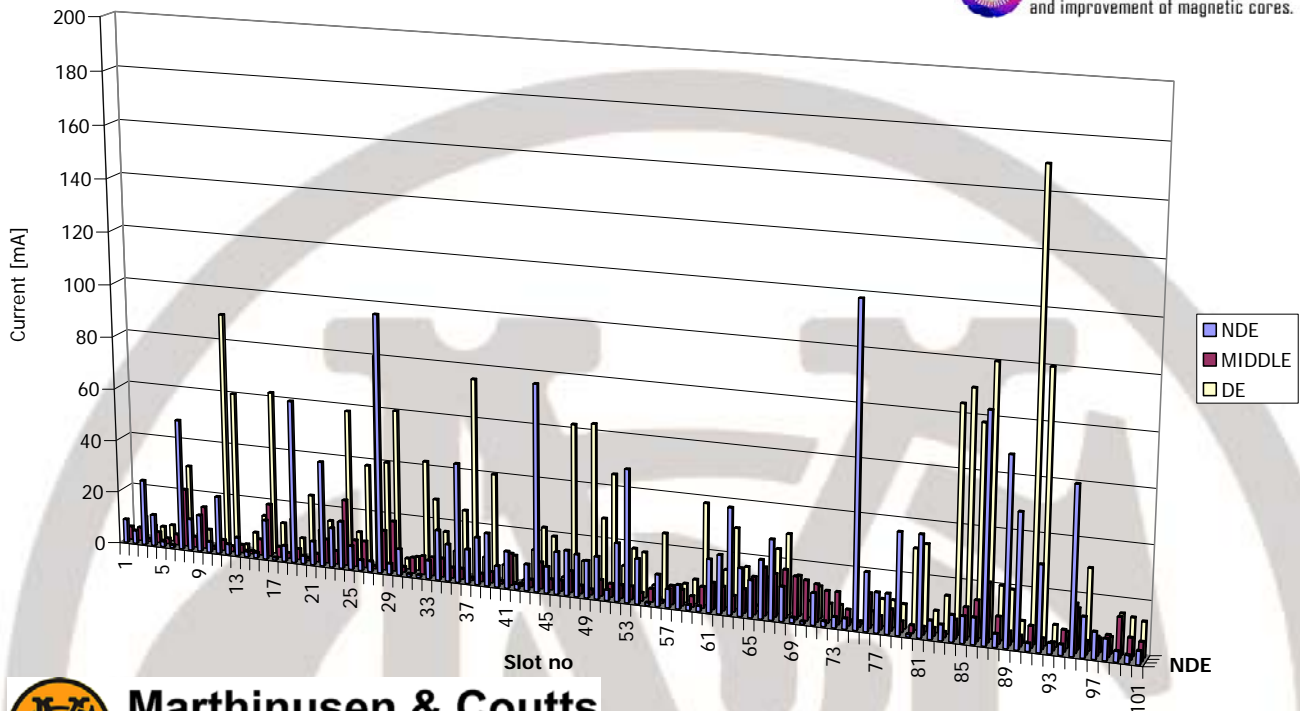
Elcid Test: After InsulCore treatment

The average result **decreased by 22.2%**. Only 1.3 % of the results were still out of specification. The average value is **84% below** the specification value.

The rotor core was treated with the InsulCore™ Solutions treatment and the El Cid test results are shown below.

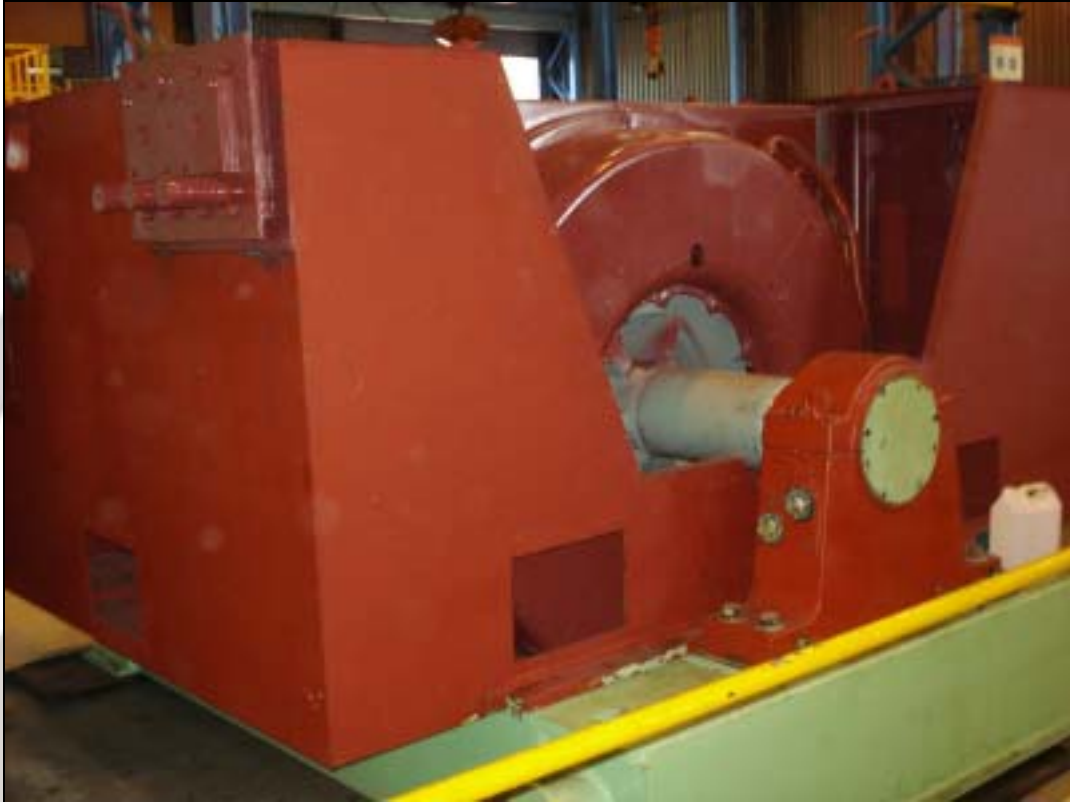
This 10 pole motor had a bearing failure, which resulted in a rotor to stator core rub.

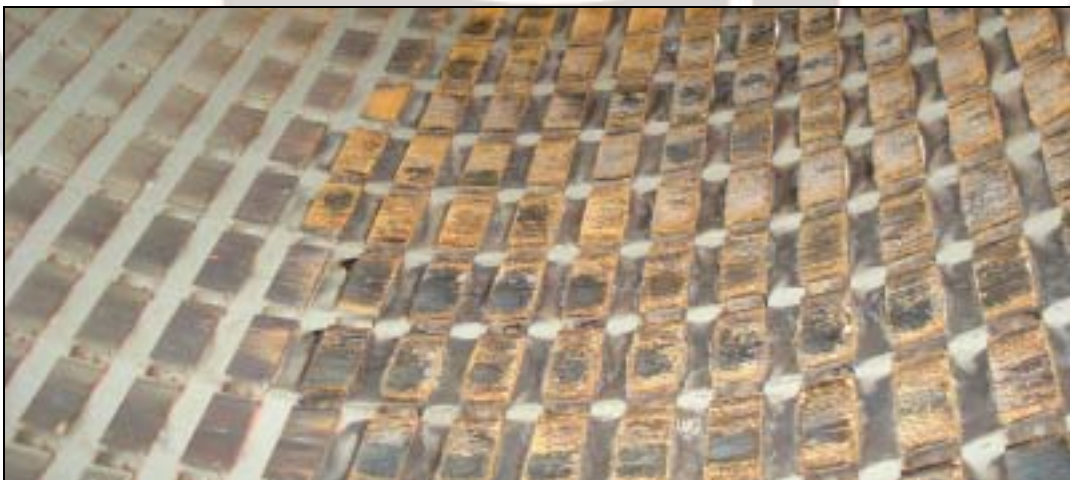
The stator winding failed and had to be rewound. The stator core test however revealed many areas of "hot spots".

This was due to the severe core rub, as can be seen in the photograph below.

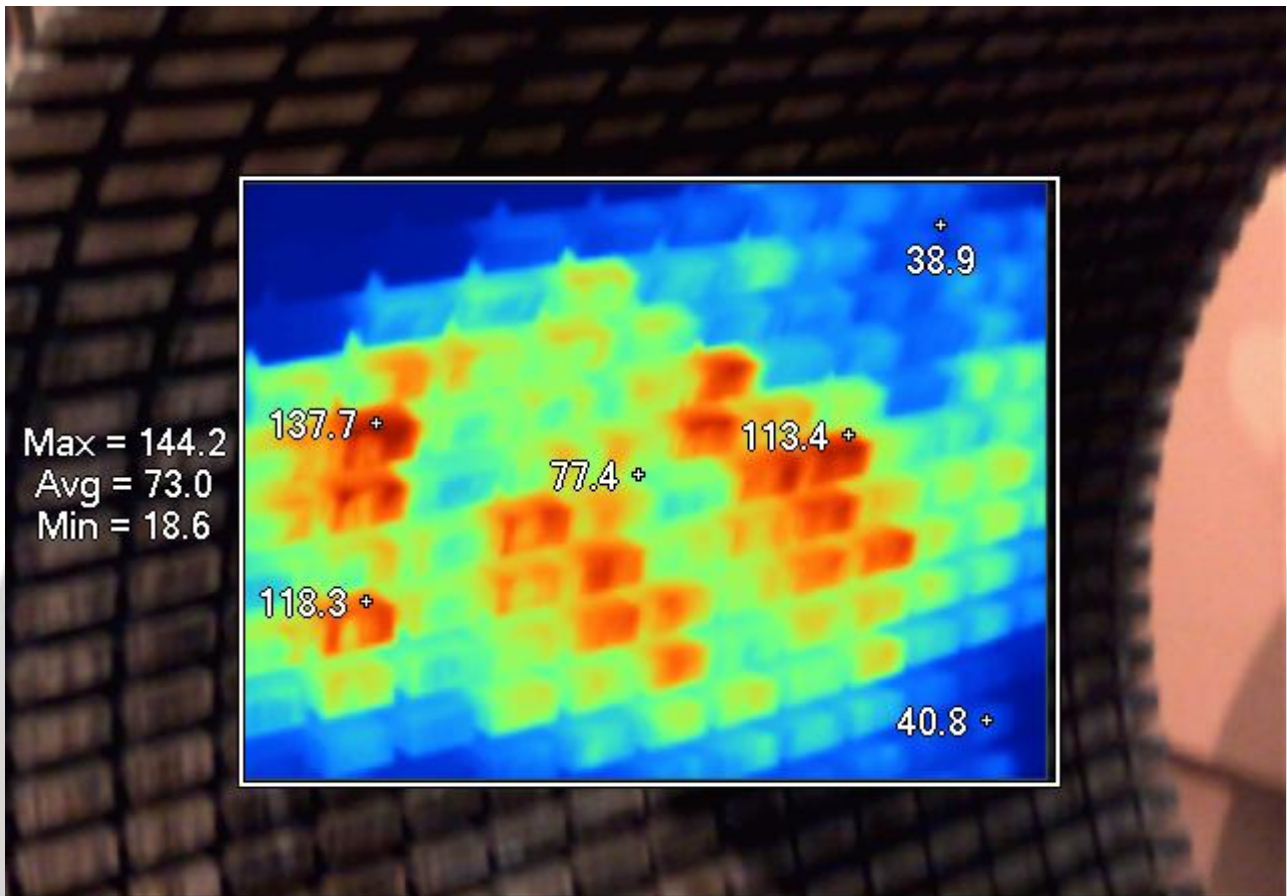
Extensive core “shocking”, “bumping” and “spreading” were unsuccessful in resolving these problem areas. The thermal scan of the stator core is shown below.

Because of the frame and core construction, a restack was not possible and the core would have to be replaced. This would have considerable cost and repair time implications.

The repair of the stator core using the InsulCore™ Solution was recommended to the customer.

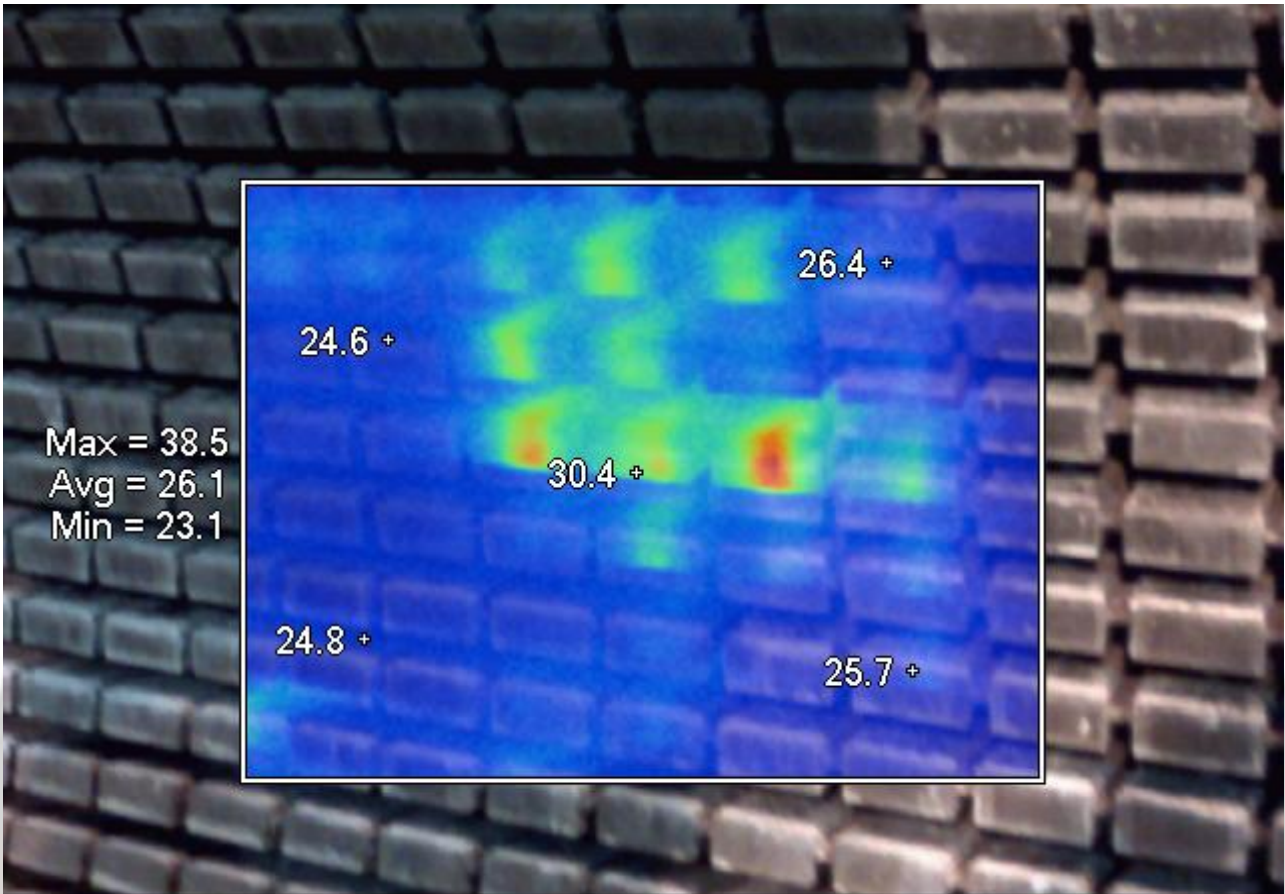
A **78.9%** drop in the hot spot temperature after the InsulCore™ Solutions treatment.

The core treatment was successful, and the thermal image of the core test is after InsulCore™ Solutions treatment is shown below.

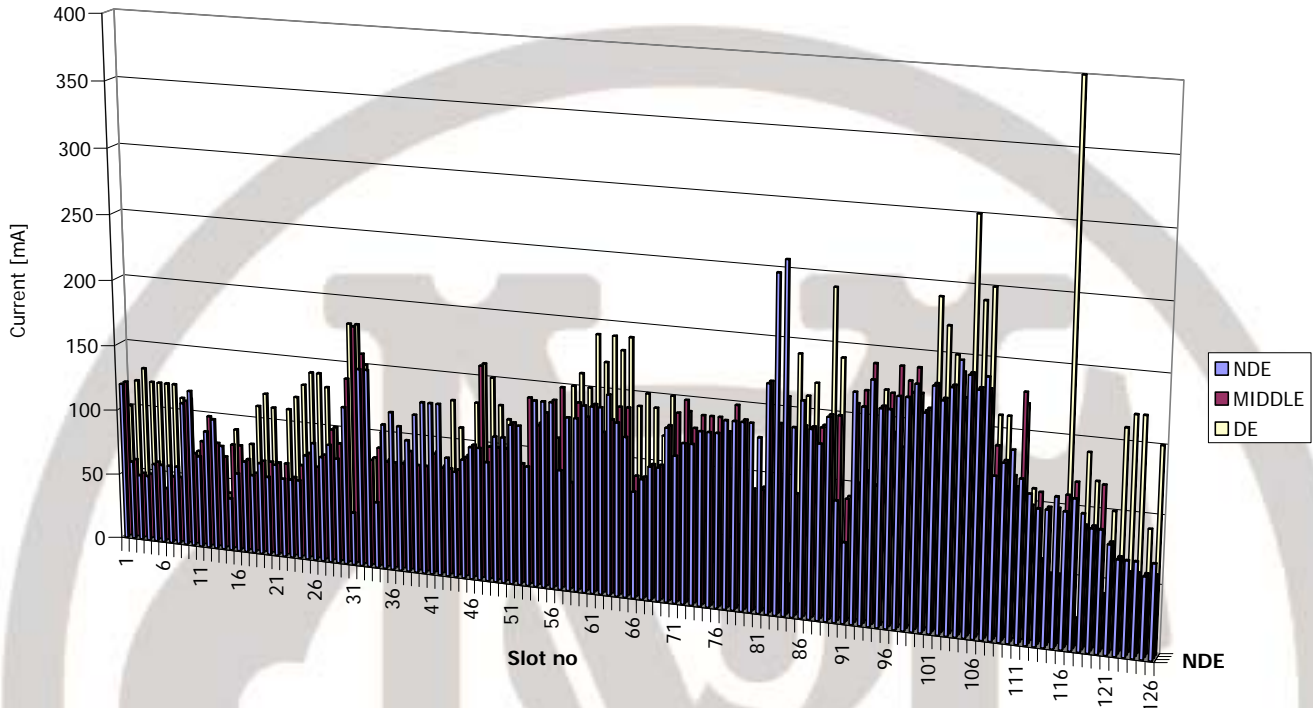
Elcid Test: Original Rotor Core Test Results

The standard M&C assessment found high core losses as indicated by the EICid test. Consultation with the customer revealed that the customer has an installed base of eight of these motors, with five of them having similar rotor core problems. These problems were identified more than twelve years ago.

55% of the El Cid results were out of specification, with the average value being 16% above the acceptable limits.

We recommended that the core could be treated using the InsulCore™ Solution treatment as a possible solution to the problem.

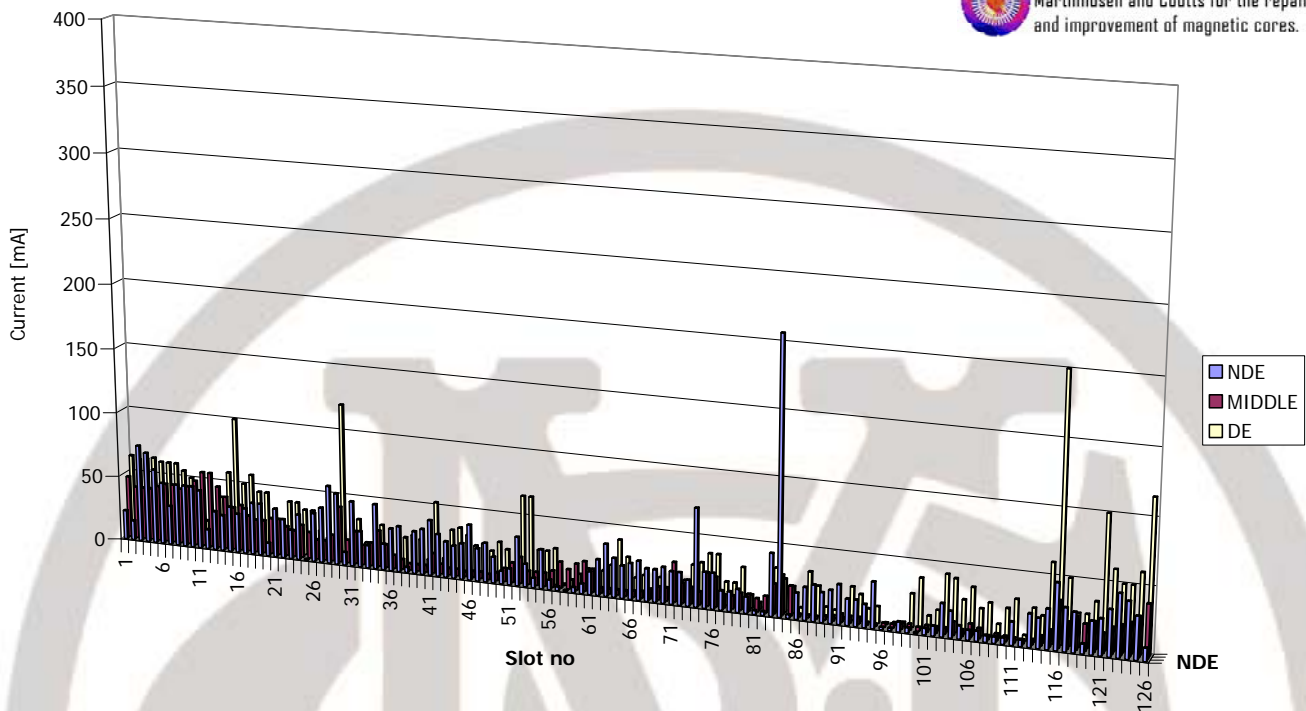
Elcid Test: After InsulCore treatment #2

The average result **decreased by 78.4 %**. Only 1.1 % of the results were still out of specification. The average value is **75% below** the specification value.

The rotor core was treated with the InsulCore™ Solutions treatment and the El Cid test results are shown below.
